Gardena R50Li Robotic lawnmower fault

den 5 juni 2025

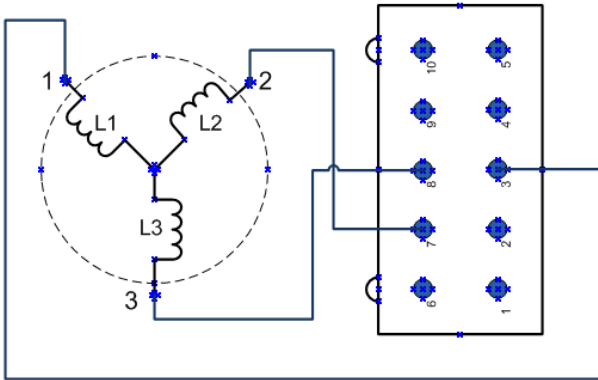
Path	Inductance	Resistance
7-8	2.014 mH	3.83 Ohm
8-3	2.061 mH	3.886 Ohm
3-7	2.052 mH	3.826 Ohm

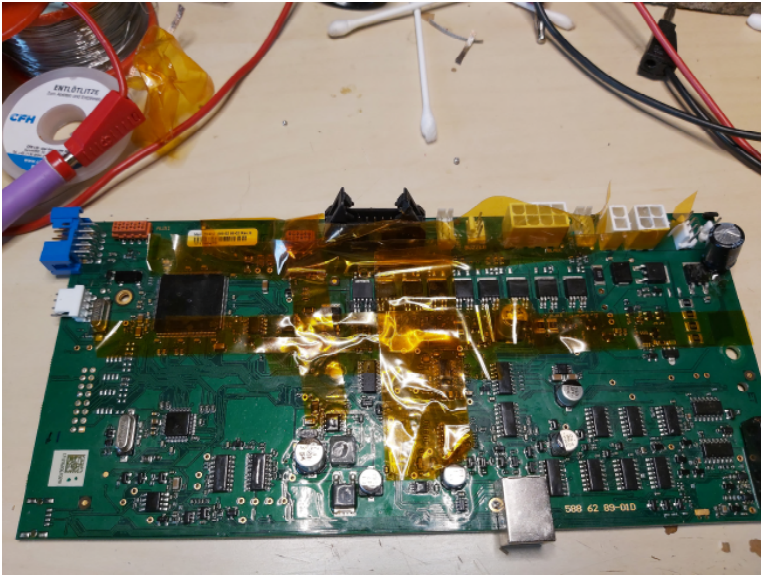
I did replace the T1 again. This time I will test without any motors connected. I will also connect G1 and G2 of T1 to channel 1,2 of an oscilloscope via a breakout circuit board. Furthermore I will connect the base of T1D to a pin on the breakout board. The reason to use a breakout board is to make an easy and reliable connection to the PCB circuits. The PCB has to be mounted in place in the unit to be able to connect all the cable connections. This makes it very difficult to reliably use the oscilloscope probes due to space constrictions. A breakout board solves this problem.

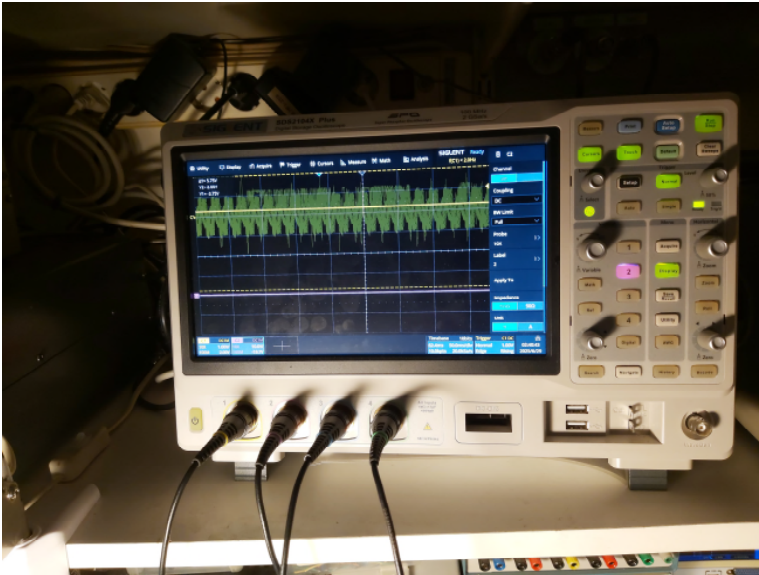
Before mounting a new MOSFET I did a control check of the transistor. Remarkably it was found to be faulty! Lucky me that I did this check. I med a red marking on the bottom of this MOSFEET to be able to identify it later. By the way all faulty MOSFET that I have replaced has been marked with red color on the top.

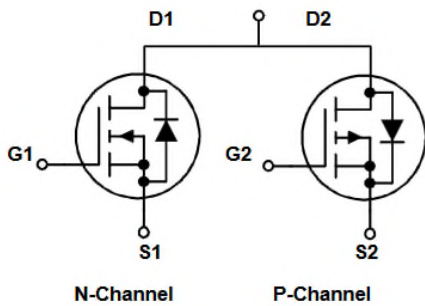
For the P-Channel MOSFET the polarity is the opposite to the above. It is wise to trun the MOSFET of before mounting the transistor to the PCB!

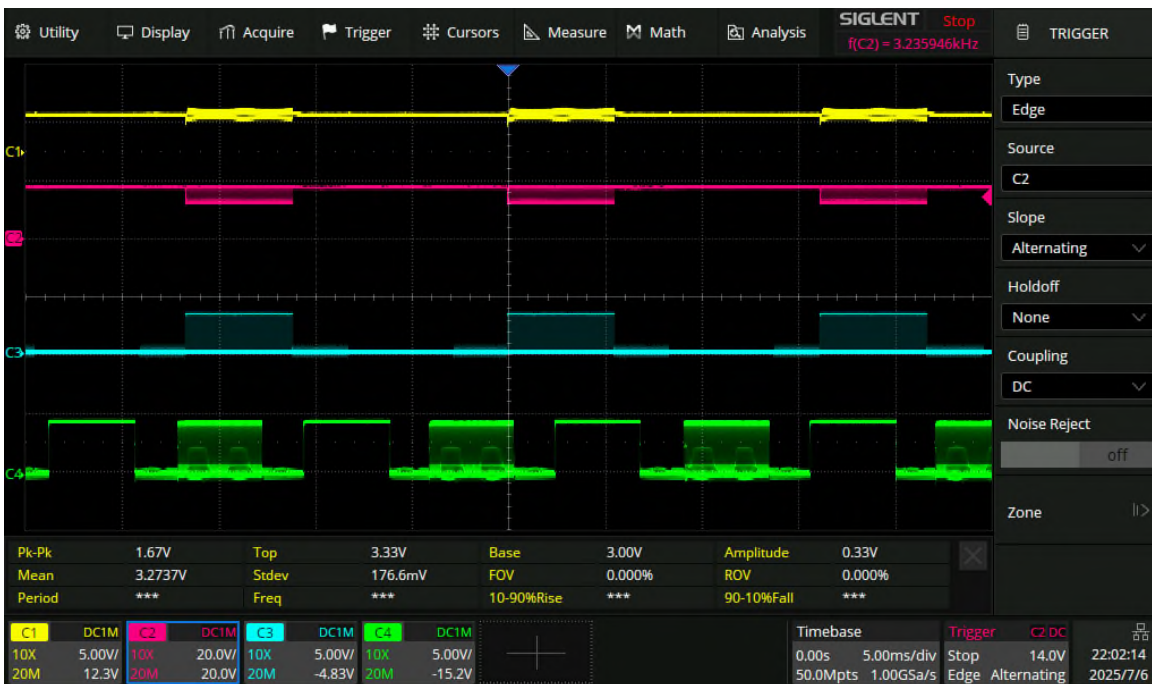
New approach for troubleshooting

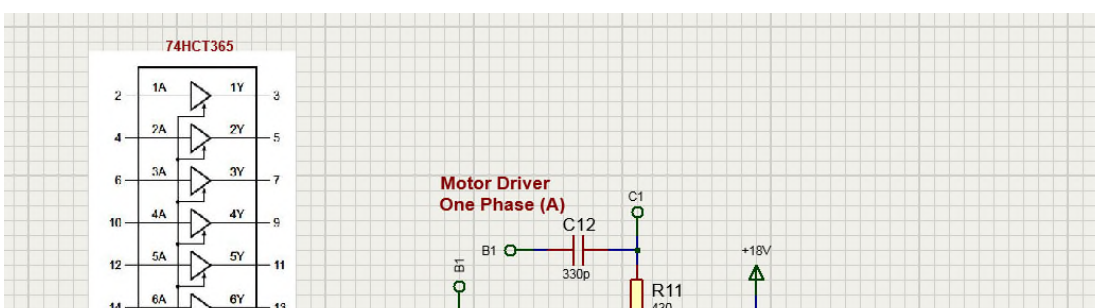
Here is an updated version of the schematics for one motor phase:

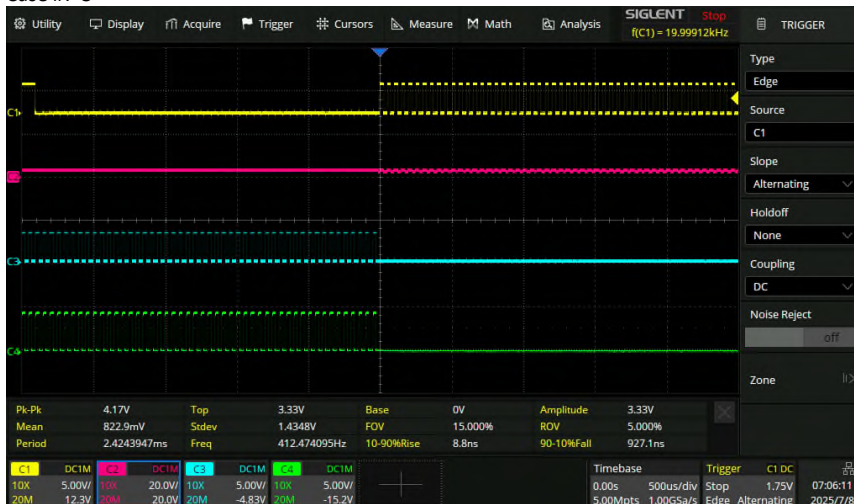
As we can see from the oscilloscope images (channel 1) above we have the input signal from the MCU to U1 MUX-X5 (A5) and it looks completely correct. However the output from this tristate buffer (Channel 2) is high all the time with some minor noise. If we compare this to the signals to T2, that are correct, we see the difference. In this measurement the test menu was activated and a test run of the wheel motors was performed. Both the wheels was rotating smoothly. However, note that a 33 ohm resistor was connected between the source of the PNP MOSFET and the +18V supply. This to protect the MOSFET to be shorted due to faulty commutation.
